AHERA/NESHAP ASBESTOS INSPECTION REPORT

112 Brent Street
Sumter, SC

November 30, 2020

SUMMIT Job No. 5563.E0004

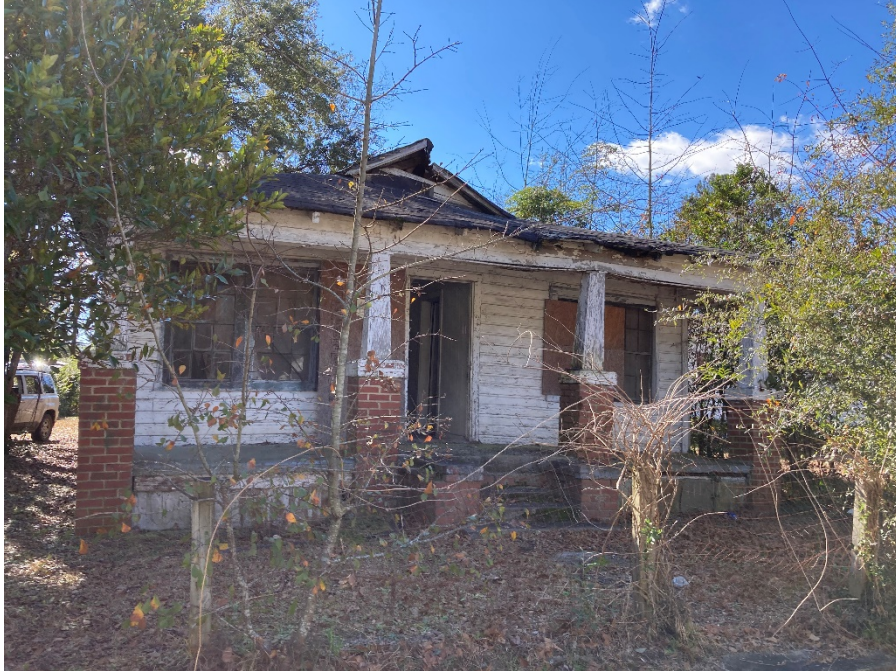
Exterior

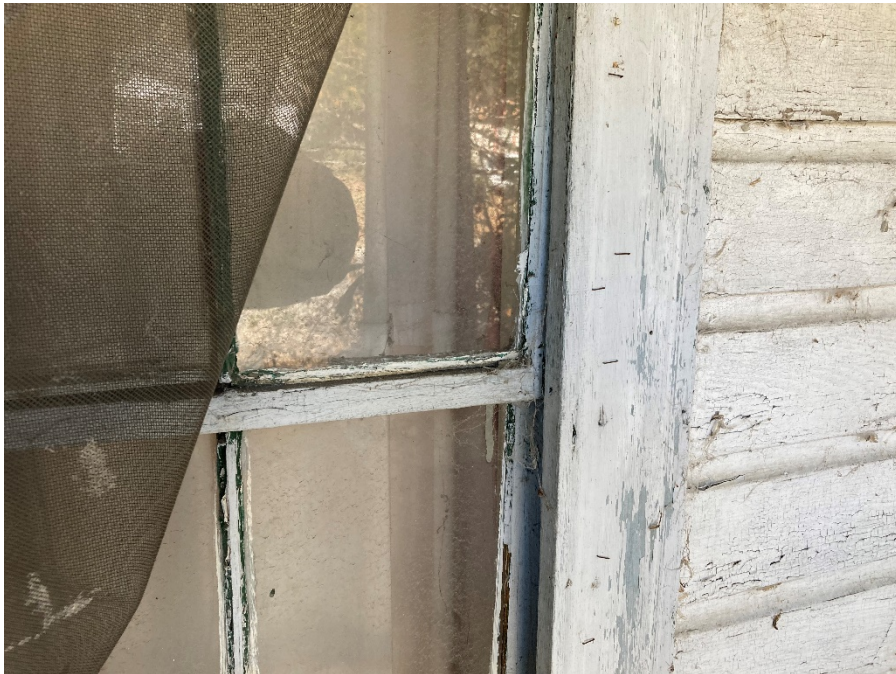
The window glazing was sampled from the windows. The results indicated that this material is not classified as an Asbestos Containing Material (ACM). The material is classified as a friable, miscellaneous material and is in damaged condition with a low potential for damage. The sample analysis of the material is enclosed in Appendix A. A detailed map showing the locations of the sampling locations can be found in the SUMMIT Documentation.

Glazing compound

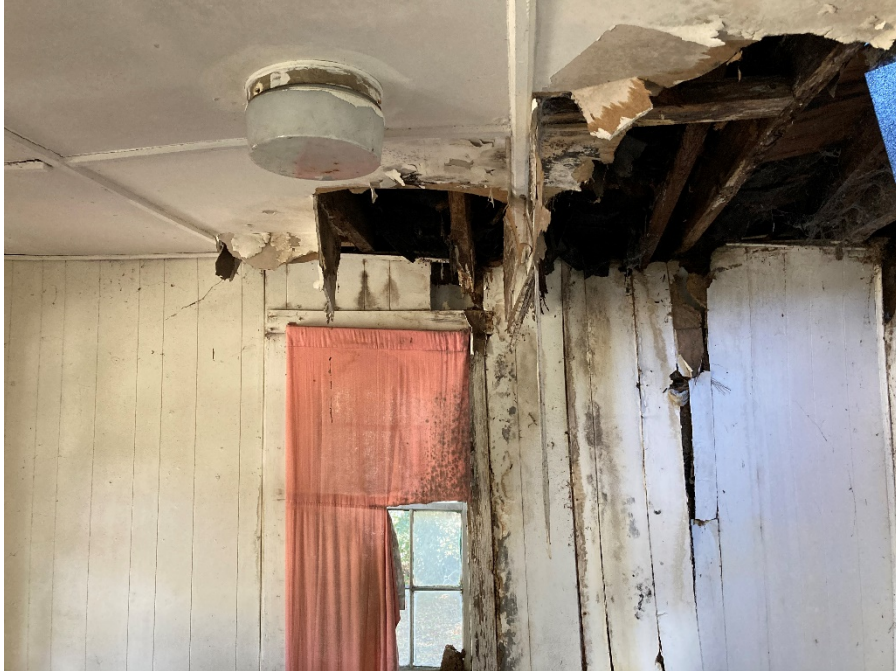
The drywall and joint compound were sampled from the ceilings throughout the residence. The results indicated that these materials are not classified as Asbestos Containing Materials (ACM). The materials are classified as friable, surfacing materials and are in damaged condition with a low potential for damage. The sample analysis of the material is enclosed in Appendix A. A detailed map showing the locations of the sampling locations can be found in the SUMMIT Documentation.

Interior drywall

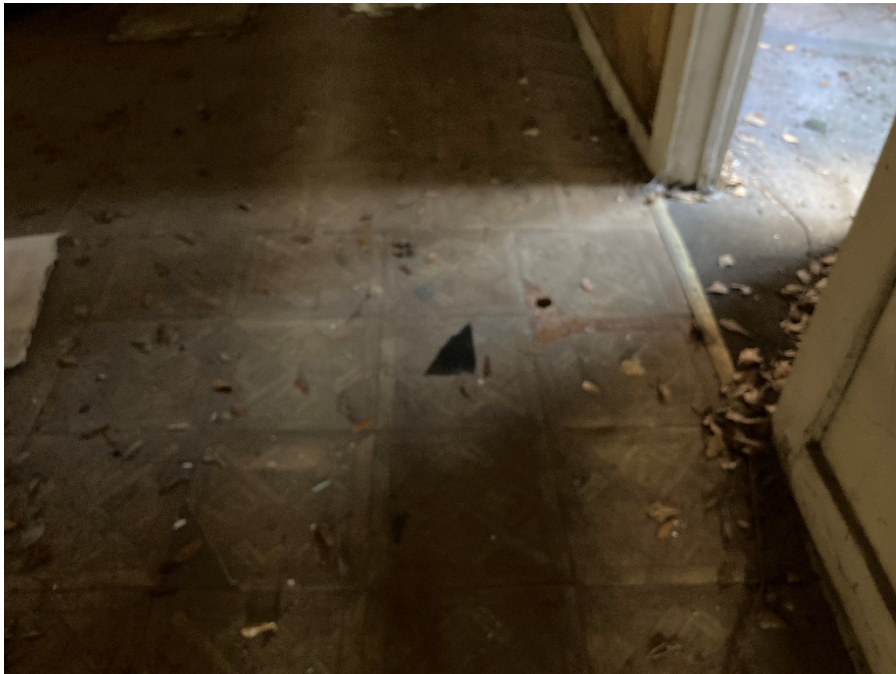
The floor tile was sampled from the kitchen. The results indicated that the floor tile is not classified as an Asbestos Containing Material (ACM). The material is classified as non-friable, miscellaneous material and is in good condition with a low potential for damage. The sample analysis of the material is enclosed in Appendix A. A detailed map showing the locations of the sampling locations can be found in the SUMMIT Documentation.

Kitchen floor tile

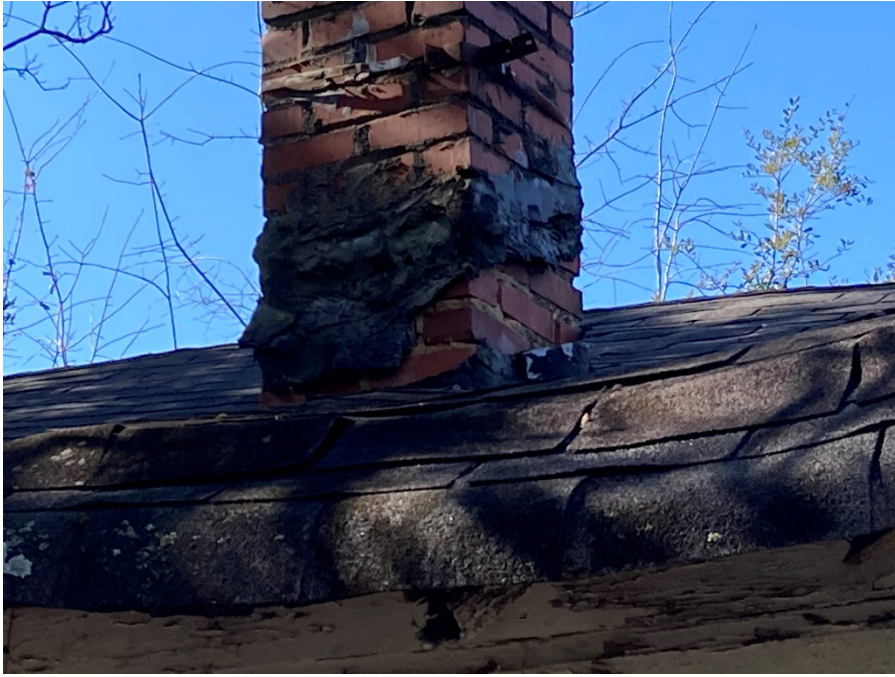
The tar was sampled from the roof. The results indicated that this material is not classified as an Asbestos Containing Material (ACM). The material is classified as a non-friable, miscellaneous material and is in good condition with a low potential for damage. The sample analysis of the material is enclosed in Appendix A. A detailed map showing the locations of the sampling locations can be found in the SUMMIT Documentation.

Chimney tar

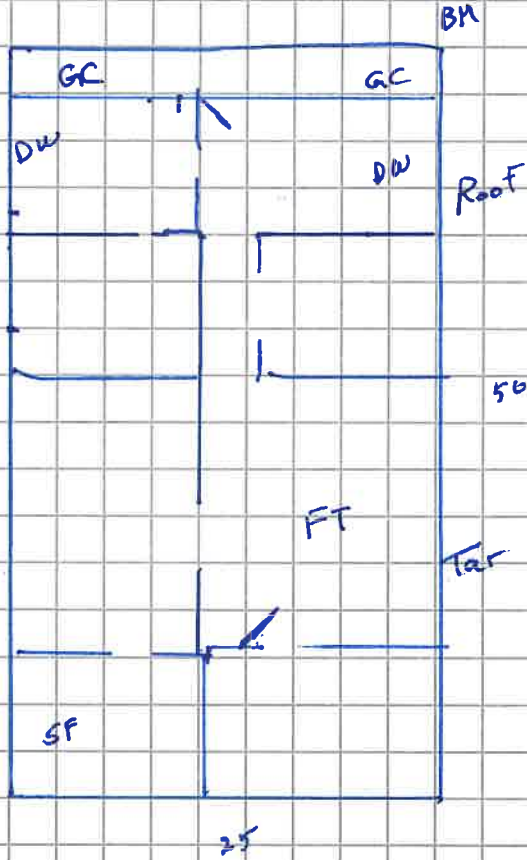
PREPARED BY: <i>JCH</i>	DATE: <i>1-28-21</i>	CHECKED BY:	DATE:	PROJECT NO:
PROJECT NAME: <i>112 Brent St.</i>				SHEET NO ___ OF ___

The roofing systems were sampled from the roof. The results indicated that this material is not classified as an Asbestos Containing Material (ACM). The material is classified as a non-friable, miscellaneous material and is in good condition with a low potential for damage. The sample analysis of the material is enclosed in Appendix A. A detailed map showing the locations of the sampling locations can be found in the SUMMIT Documentation.
