AHERA/NESHAP ASBESTOS INSPECTION REPORT

26 Brent Street
Sumter, SC

SUMMIT Job No. 5563.E0007

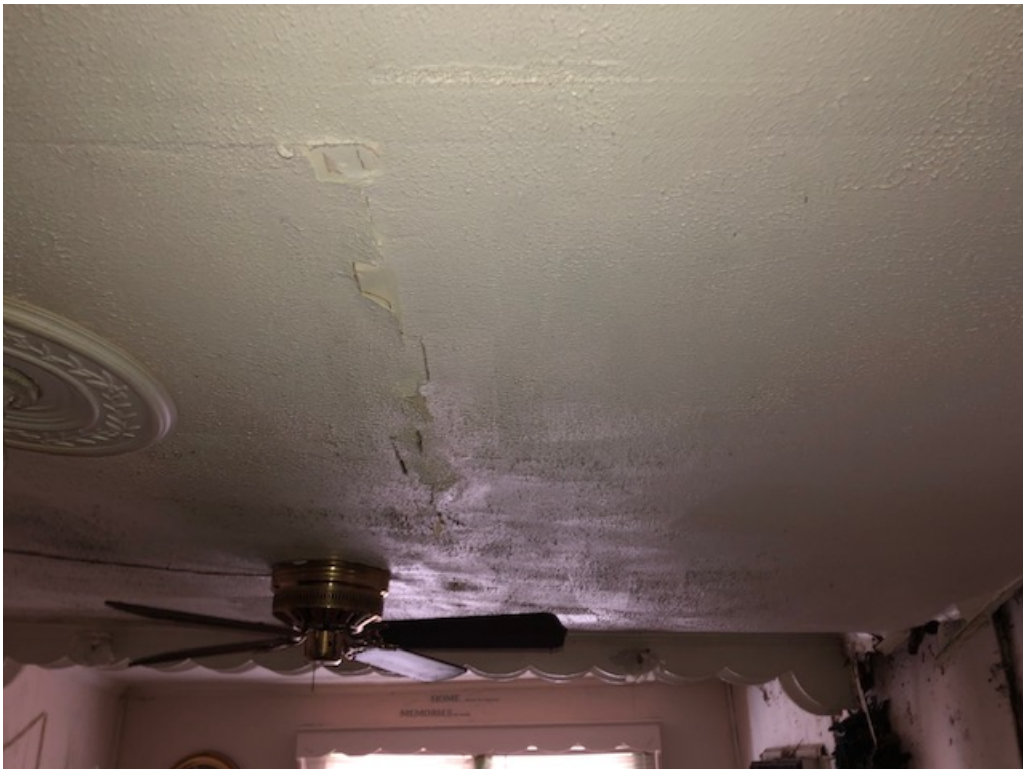
The ceiling texture was sampled from the living room. The results indicated that these materials are not classified as Asbestos Containing Materials (ACM). The materials are classified as friable, surfacing materials and are in good condition with a low potential for damage. The sample analysis of the material is enclosed in Appendix A. A detailed map showing the locations of the sampling locations can be found in the SUMMIT Documentation.

This photo depicts the ceiling texture in the living room.

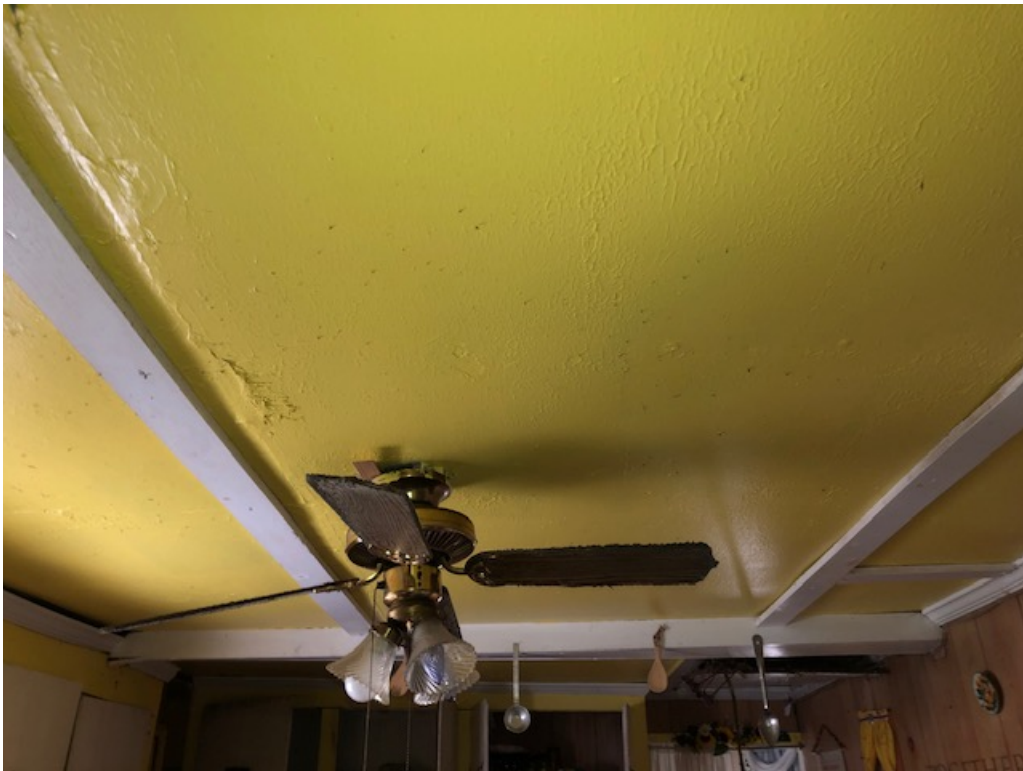
This photo depicts the ceiling in the kitchen.

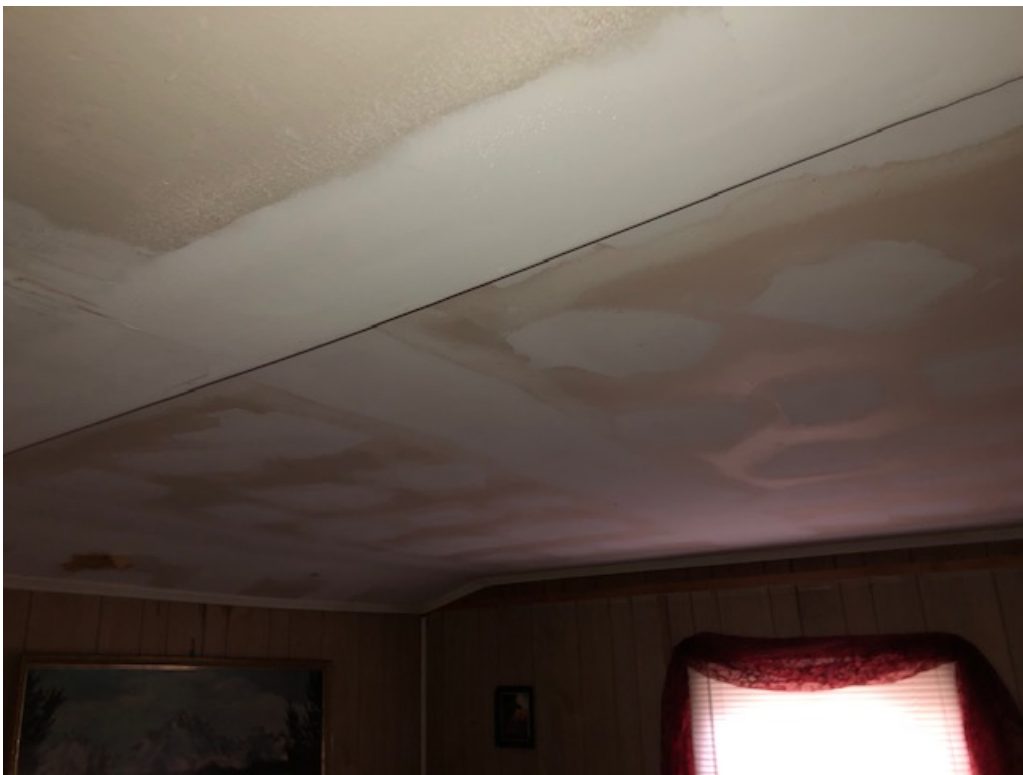
The ceiling texture was sampled from bedroom 2. The results indicated that these materials are not classified as Asbestos Containing Materials (ACM). The materials are classified as friable, surfacing materials and are in good condition with a low potential for damage. The sample analysis of the material is enclosed in Appendix A. A detailed map showing the locations of the sampling locations can be found in the SUMMIT Documentation.

This photo depicts a view of the ceiling in the bedroom.

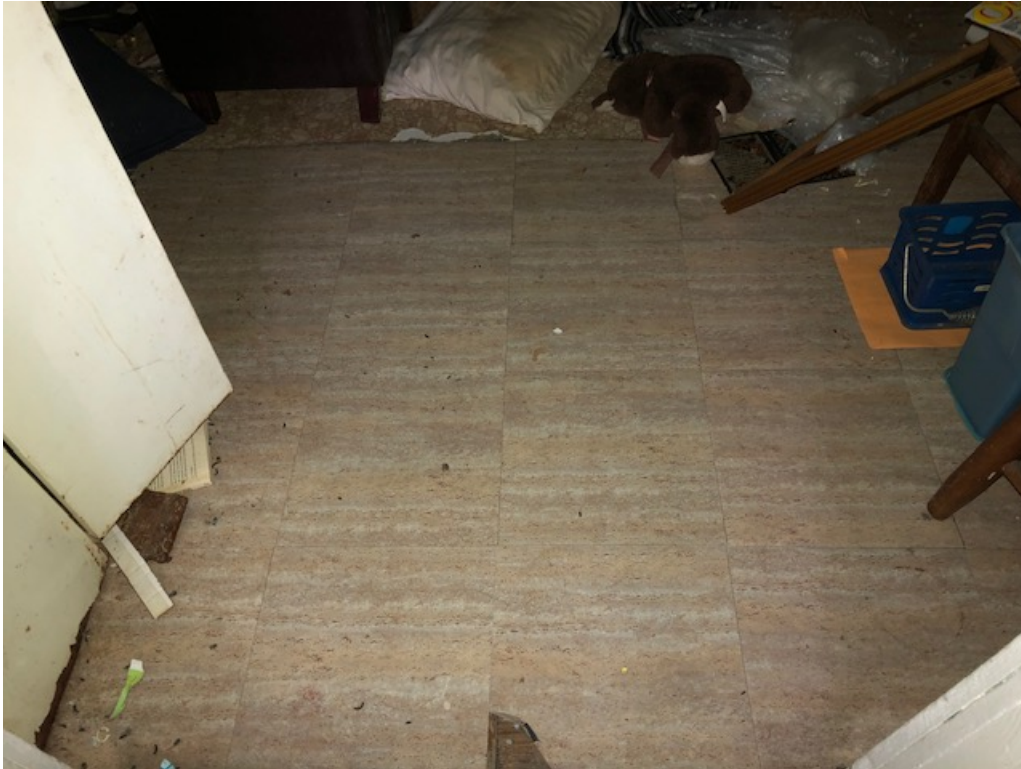
The floor tiles were sampled from bedroom 1. The results indicated that this material is not classified as an Asbestos Containing Material (ACM). The material is classified as a non-friable, miscellaneous material and is in good condition with a low potential for damage. The sample analysis of the material is enclosed in Appendix A. A detailed map showing the locations of the sampling locations can be found in the SUMMIT Documentation.

This photo depicts the floor tile in bedroom 1.

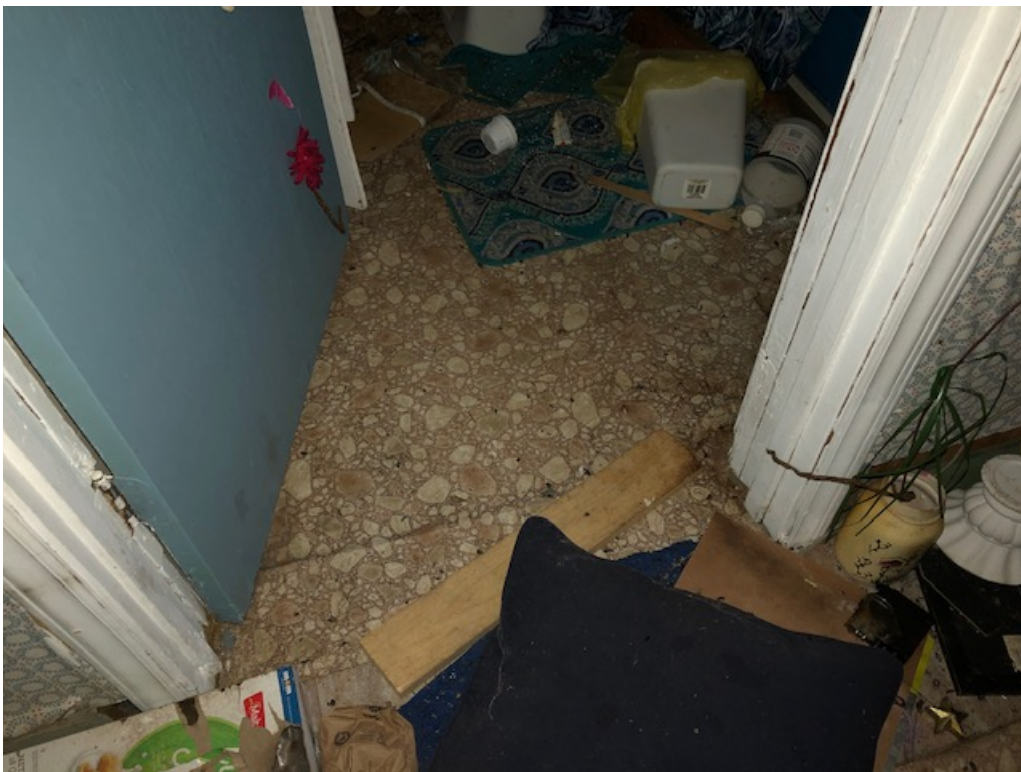
The sheet flooring was sampled from the bathroom. The results indicated that the sheet flooring is not classified as an Asbestos Containing Material (ACM). The material is classified as non-friable, miscellaneous material and is in good condition with a low potential for damage. The sample analysis of the material is enclosed in Appendix A. A detailed map showing the locations of the sampling locations can be found in the SUMMIT Documentation.

This photo depicts the sheet flooring sampled from the bathroom.

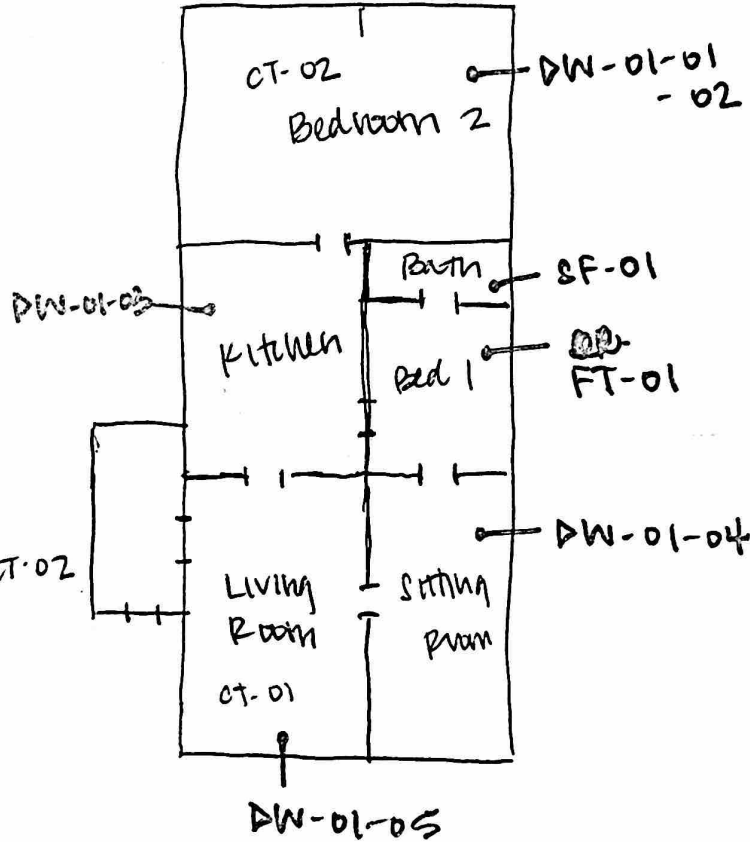
26
48 Brent Street. 48x20

Living Room:
ceiling texture
CT-01

Window glare
routing (shingles).

Attic Room:
DNJC on ceiling.
wood paneling.
carpet.

Kitchen
ceiling texture

Bed 1
Floor tile
sheet flooring

Bath
sheet flooring

Bedroom 2
Popcorn ceiling - CT-02
carpet.
